Wisconsin Department of Transportation

Outstanding Highway Construction Awards

Asphalt Paving Category

Interstate 94, East-West Freeway

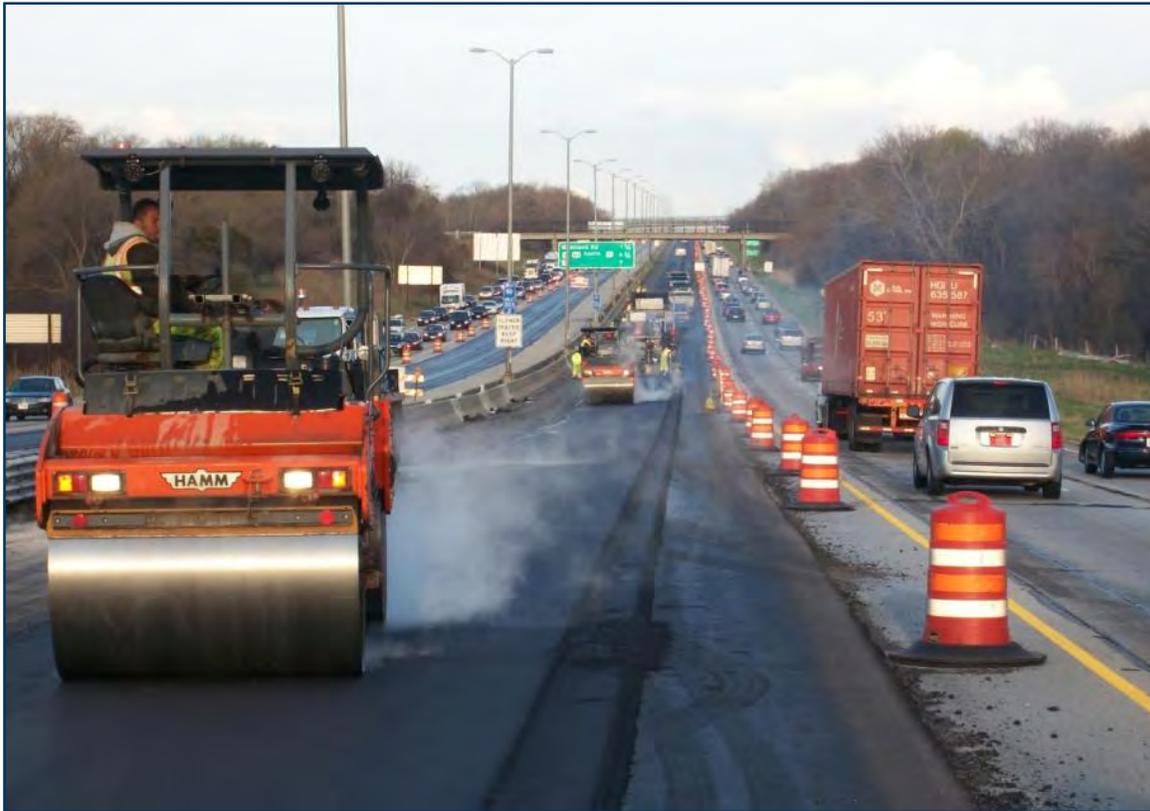
HMA surface paving, I-94 westbound, Waukesha County

Several techniques were implemented on the project so that longitudinal joint deterioration would be minimized in subsequent years. The two primary longitudinal joints of concern lie between lanes 1 & 2 and lanes 2 & 3. Lanes 2 and 3 (24 feet in total width) were paved in tandem, so that there was never a true cold joint created between the two lanes. The joint between lanes 1 and 2 is a true cold joint, but a longitudinal butt joint was created prior to placing the adjacent pavement, optimizing HMA thickness and compaction efforts. A longitudinal joint reheater was also used at this joint, likely decreasing the chances of deterioration.

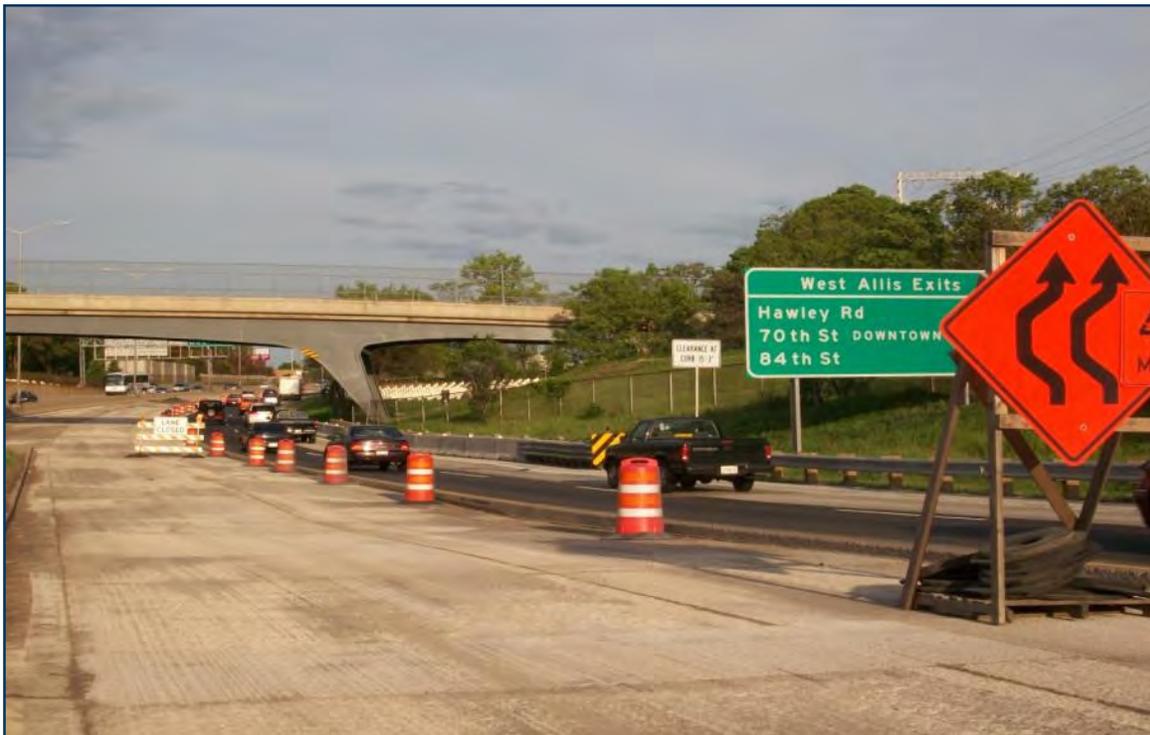
Traffic Staging, I-94 westbound, Milwaukee County

- Weekly traffic control coordination meetings
- Pre-stage switch coordination meetings—There were 12 significant stage changes during the project, or an average of one significant stage change every 2 weeks during spring and early summer
- Local Sheriff and State Highway Patrol attendance and input/suggestions at all traffic and stage-related meetings
- Weekly construction team safety meetings
- Three members of the traffic control inspection team, allowing continuous monitoring and coverage of work, and ensuring device compliance with the *Manual on Uniform Traffic Control Devices*

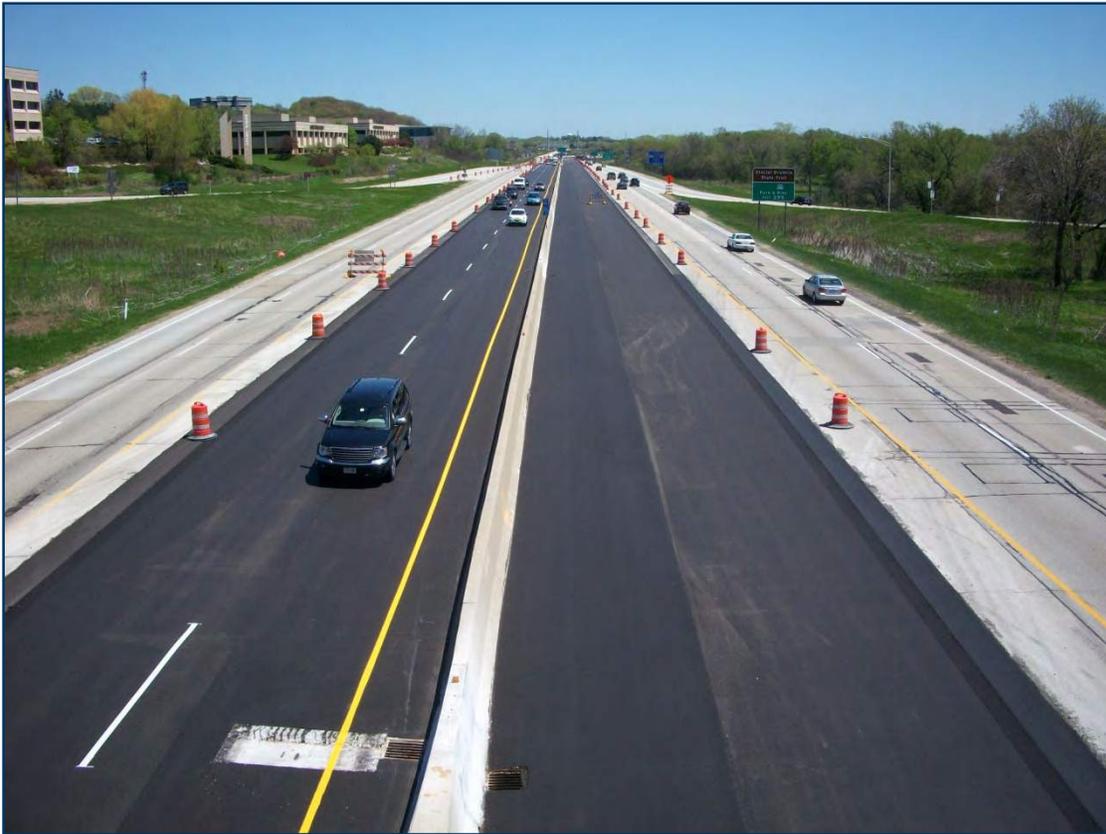
Traffic Staging, Waukesha County

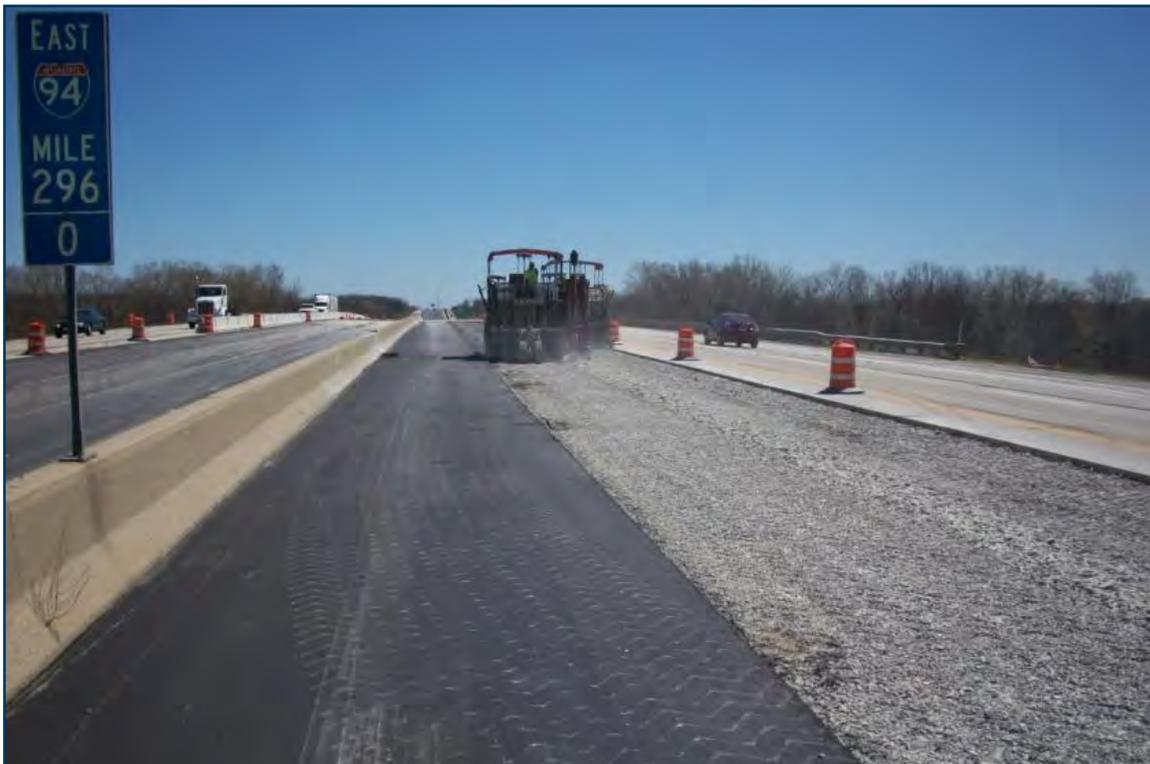
Rubblizing, I-94 eastbound, Waukesha County

The typical existing roadway section consists of a 3- to 5-inch asphaltic surface, a 9-inch concrete base, and a granular sub-base. The existing asphaltic surface was milled, and the 9-inch concrete base was rubblized or base patched.

The project plans indicated that the HMA was to be completed in two layers. After careful consideration, the construction engineering team and the contractor determined that it would be best over the rubblized areas to pave the road with three layers of HMA. This method used a “leveling layer” installed directly onto the rubblized surface, followed by a 3-inch binder layer and then a 2-inch surface layer. Optimal surface smoothness was achieved by use of this method, as any inconsistencies in the rubblized pavement could be eliminated. The contractor also used a profile mill on the new lower HMA layers to provide for the best possible ride on the new pavement. Lastly, there were three separate production plants and an aggregate source solely devoted to this project, which provided a consistent mix and the ability to deliver the HMA such that the accelerated project schedule could be met.

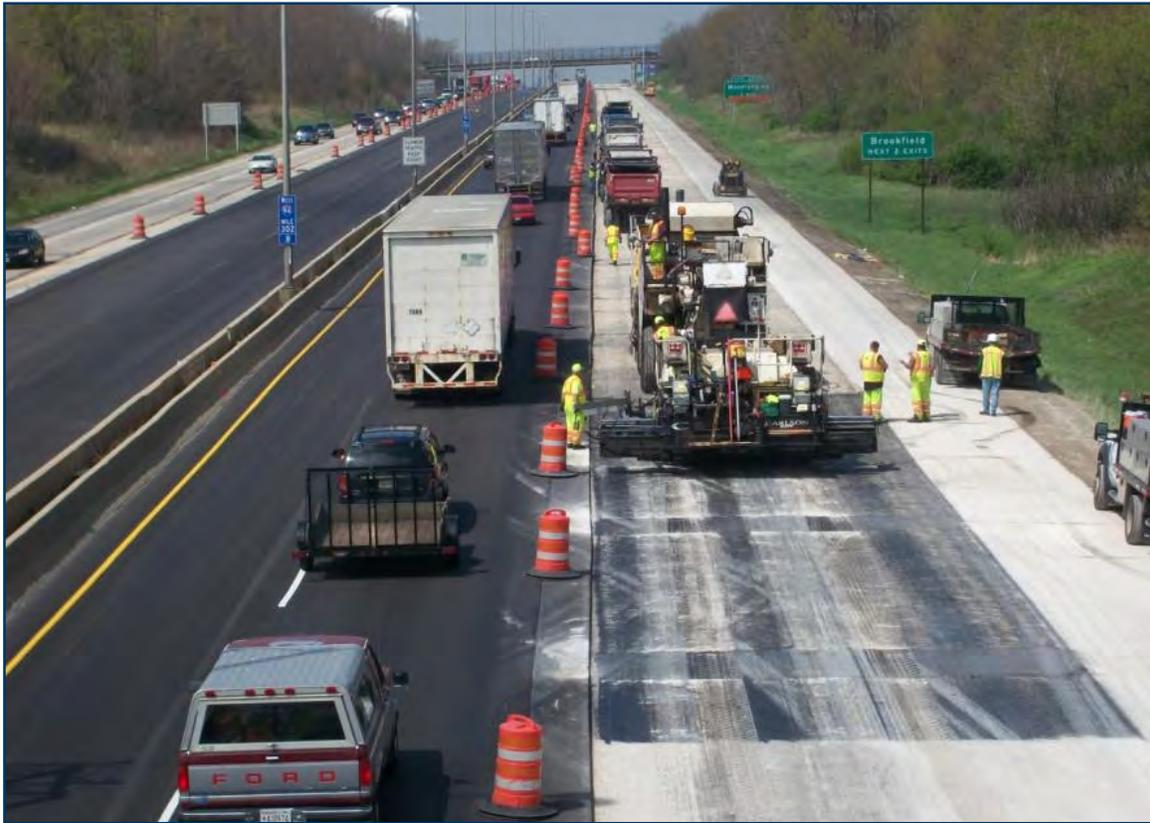
HMA paving, I-94 westbound, Waukesha County
